# MSP430AFE222 Device Erratasheet

## 1 Functional Errata Revision History

## 6 Detailed Bug Description

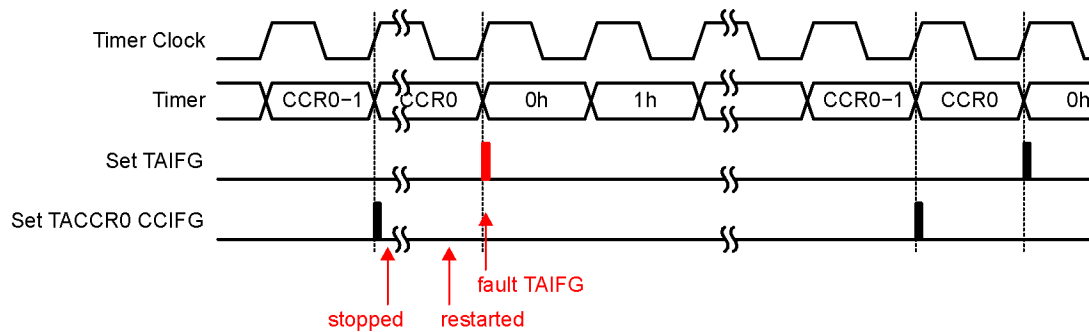
**TA21** *TIMER\_A Module*

<b>Category</b>	Functional
<b>Function</b>	TAIFG Flag is erroneously set after Timer A restarts in Up Mode
<b>Description</b>	In Up Mode, the TAIFG flag should only be set when the timer counts from TACCR0 to zero. However, if the Timer A is stopped at TAR = TACCR0, then cleared (TAR=0) by setting the TACLR bit, and finally restarted in Up Mode, the next rising edge of the TACLK will erroneously set the TAIFG flag.

**Workaround** None.
