TMS320F2837xS MCUs Silicon Revisions C, B

This document describes the silicon updates to the functional specifications for the TMS320F2837xS microcontrollers (MCUs).

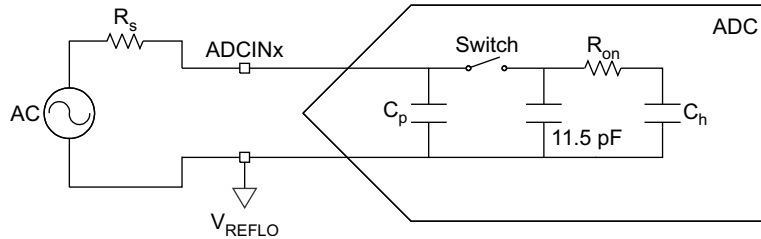
Figure 3. Single-Ended Input Model

The ADC input model should be used to select the sample-and-hold (S+H) duration for each ADC input. For the revisions affected, if the currently converting channel is an even-numbered channel and the previously converted channel was an odd-numbered channel (or vice versa), then the 12-bit input model will not accurately predict ADC input performance. Under these conditions, an additional capacitance should be added to the model. This capacitance has a value of 11.5 pF and should be placed between the S+H switch and R_{on} as shown in [Figure 3](#).

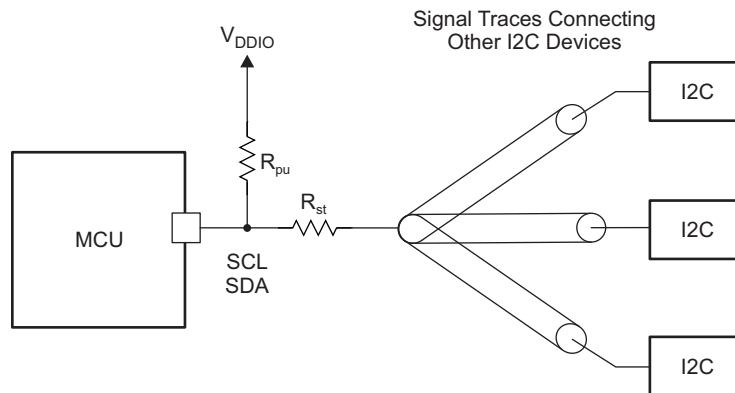
Figure 7. Placement of Series Termination Resistor and Pullup Resistor

The SDA and SCL outputs are implemented with push-pull 3-state output buffers rather than open-drain output buffers as required by I2C. While it is possible for the push-pull 3-state output buffers to behave as open-drain outputs, an internal timing skew issue causes the outputs to drive a logic-high for a duration of 0–5 ns before the outputs are disabled. The unexpected high-level pulse will only occur when the SCL or SDA outputs transition from a driven low state to a high-impedance state and there is sufficient internal timing skew on the respective I2C output.

This short high-level pulse injects energy in the I2C signals traces, which causes the I2C signals to sustain a period of ringing as a result of multiple transmission line reflections. This ringing should not cause an issue on the SDA signal because it only occurs at times when SDA is expected to be changing logic levels and the ringing will have time to damp before data is latched by the receiving device. The ringing may have enough amplitude to cross the SCL input buffer switching threshold several times during the first few nanoseconds of this ringing period, which may cause clock glitches. This ringing should not cause a problem if the amplitude is damped within the first 50 ns because I2C devices are required to filter their SCL inputs to remove clock glitches. Therefore, it is important to design the PCB signal traces to limit the duration of the ringing to less than 50 ns. One possible solution is to insert series termination resistors near the SCL and SDA terminals to attenuate transmission line reflections.

This issue may also cause the SDA output to be in contention with the slave SDA output for the duration of the unexpected high-level pulse when the slave begins its ACK cycle. This occurs because the slave may already be driving SDA low before the unexpected high-level pulse occurs. The glitch that occurs on SDA as a result of this short period of contention does not cause any I2C protocol issue but the peak current applies unwanted stress to both I2C devices and potentially increases power supply noise. Therefore, a series termination resistor located near the respective SDA terminal is required to limit the current during the short period of contention.

Insert series termination resistors on the SCL and SDA signals and locate them near the SCL and SDA terminals. The SCL and SDA pullup resistors should also be located near the SCL and SDA terminals. The placement of the series termination resistor and pullup resistor should be connected as shown in [Figure 7](#).
