ERRATA NOTES

CC2550

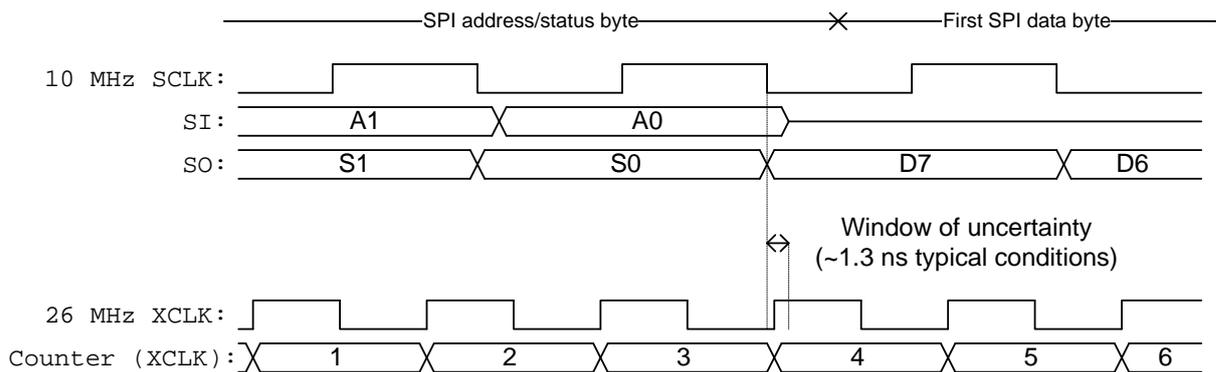
Figure 1: Window of Uncertainty (drawing not to scale)

Due to this synchronization issue, if the register being read changes value (synchronously with XCLK) during a certain period of time after this falling edge of SCLK then some of the bits in the read value will come from the **previous** value and some from the **next** value. This so-called window of uncertainty is about 1.3 ns for typical conditions and increases to about 2.0 ns for worst-case conditions (1.8 V VDD, 85 °C).

Figure 1 shows a timing diagram of an SPI read that fails when reading a fictitious counter being updated internally each **XCLK**. Since the counter update from value **3** (011b) to **4** (100b) within the window of uncertainty, the read value could be any one of 0-7 (000b, 001b, 010b, 011b, 100b, 101b, 110b, 111b) depending on exactly when the positive edge of **XCLK** falls within the window of uncertainty.

If it is important to **ensure** that read values are not corrupted, reading of one of the affected registers should be done repeatedly until the same value is read twice in succession. If the rate at which the register is read is guaranteed to be at least twice as fast as the expected register update rate, then an upper bound on the number of required reads is four and the average number of reads slightly more than two.
