# Errata AM263Px Sitara™ Microcontroller Silicon Revision 1.0

## ABSTRACT

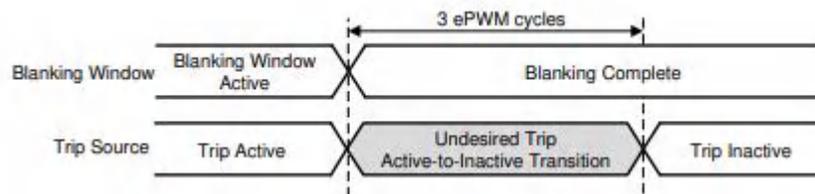
The blanking window is typically used to mask any PWM trip events during transitions which would be false trips to the system. If an ePWM trip event remains active for less than three ePWM clocks after the end of the blanking window cycles, there can be an undesired glitch at the ePWM output.

The following picture illustrates the time period which could result in an undesired ePWM output.

**Workaround(s):** Avoid configuration of blanking window such that the trip input would fall in this range (1 cycle before and 3 cycles after the blanking window closure).

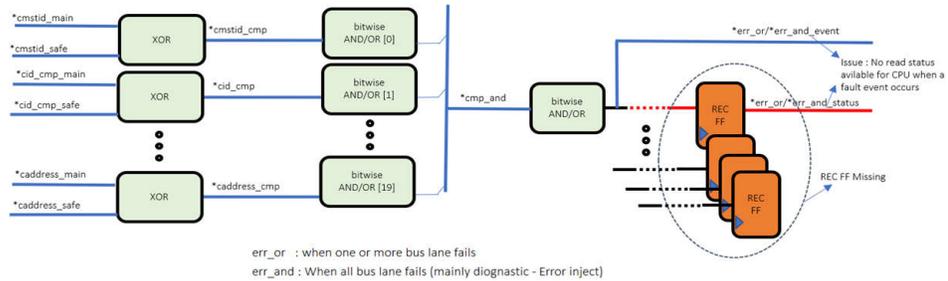
**Figure 2-1.**

There are two possible scenarios:

Case 1: Log registers have non-zero values

Here the granular logs are captured correctly and appropriate action can be taken for a given fault.

Case 2: Log Registers have all zeros

Here the granular logs are not captured correctly and possible entities affected are R5F and L2 memory.

No Workaround.

As Granular Error Status is not logged, the bus safety fault is detected only as an aggregated error event and the Granularity of diagnostics information will not be captured correctly.

Case 1: In the case where the logs are captured correctly the log results can be used to take appropriate action.

Case 2: In the case where the logs are not captured correctly then for a) diagnostics no action needed and b) in case of actual failure in the application WarmReseth should be used.

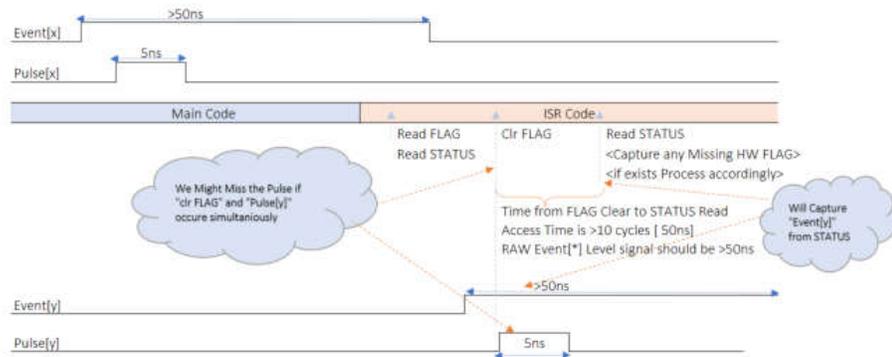
Potential race condition in capture registers resulting in events getting lost while other events in the same register are being cleared by writing to the register. Following registers are impacted by this issue:

WA-1: ISR Sequence:

- Read FLAG Event[x]
- Read STATUS, All events
- Clr FLAG, Event[x]
- Read STATUS, All events
- Capture any missing HW event FLAG
- If exists, process accordingly

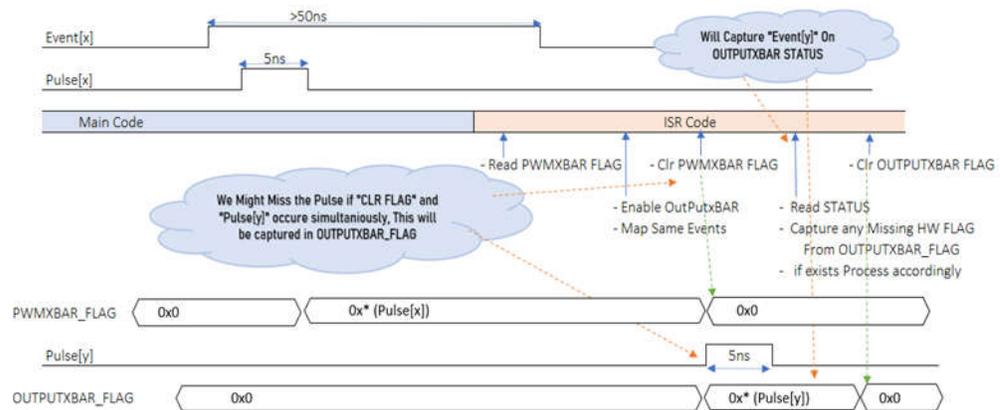
WA -2 (For any event widths):

Enable OUTPUTXBAR with the same events in the ISR and then “Clr PWMXBAR FLAG”.

WA-2: ISR Sequence:  
 Read FLAG Event[x]  
 Read STATUS, All events  
 Enable OutPutxBAR  
 - Map Same Events  
 Clr FLAG, Event[x] PWMXBAR  
 Read STATUS  
 - Capture any Missing HW event FLAG  
 from OUTPUTXBAR\_FLAG  
 if exists Process accordingly  
 - Clr FLAG, Event[y] OutputXBAR
