ABSTRACT

This document describes the known exceptions to the functional specifications (advisories).

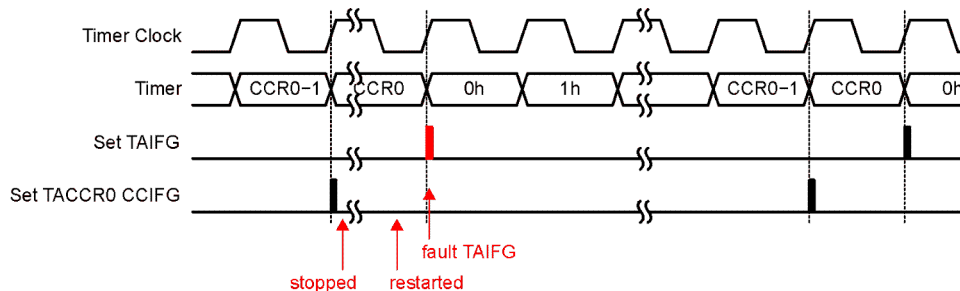
TA21 *TA Module*

Function TAIFG Flag is erroneously set after Timer A restarts in Up Mode

Description In Up Mode, the TAIFG flag should only be set when the timer counts from TACCR0 to zero. However, if the Timer A is stopped at TAR = TACCR0, then cleared (TAR=0) by setting the TACLK bit, and finally restarted in Up Mode, the next rising edge of the TACLK will erroneously set the TAIFG flag.

Workaround None.
