## ABSTRACT

This document describes the known exceptions to the functional specifications (advisories).

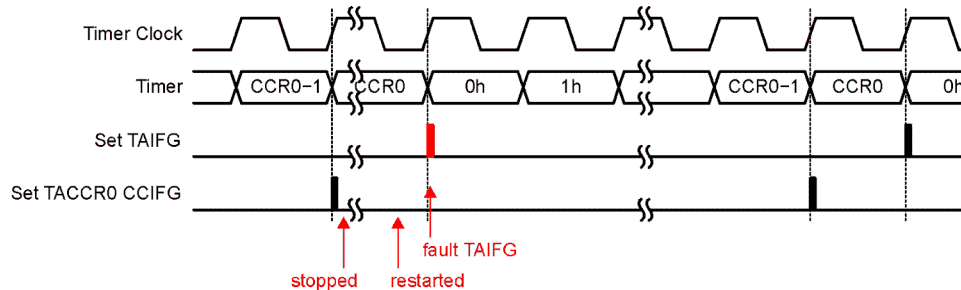
## TA21 *TA Module*

<b>Category</b>	Functional
<b>Function</b>	TAIFG Flag is erroneously set after Timer A restarts in Up Mode
<b>Description</b>	In Up Mode, the TAIFG flag should only be set when the timer counts from TACCR0 to zero. However, if the Timer A is stopped at TAR = TACCR0, then cleared (TAR=0) by setting the TACLR bit, and finally restarted in Up Mode, the next rising edge of the TACLK will erroneously set the TAIFG flag.

**Workaround** None.
