Errata  
**MSP430F46171 Microcontroller**

This document describes the known exceptions to the functional specifications (advisories).

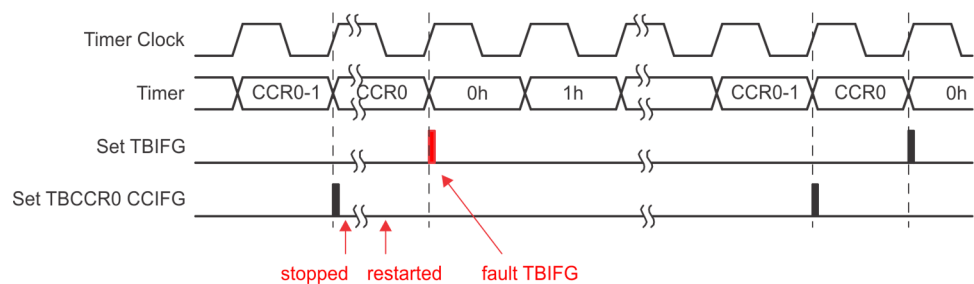
## TB24 *TB Module*

<b>Category</b>	Functional
<b>Function</b>	TBIFG Flag is erroneously set after Timer B restarts in Up Mode
<b>Description</b>	In Up Mode, the TBIFG flag should only be set when the timer resets from TBCCR0 to zero. However, if the Timer B is stopped at TBR = TBCCR0, then cleared (TBR=0) by setting the TBCLR bit, and finally restarted in Up Mode, the next rising edge of the TBCLK will erroneously set the TBIFG flag.

<b>Workaround</b>	None.
-------------------	-------
