MSP430F5341 Device Erratasheet

The revision of the device can be identified by the revision letter on the [Package Markings](#) or by the [HW_ID](#) located inside the TLV structure of the device

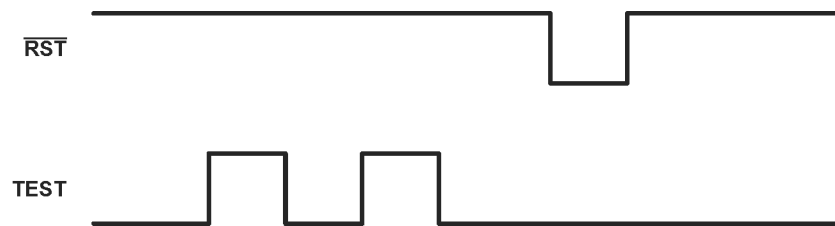
JTAG20
JTAG Module

Category	Software in ROM
Function	BSL does not exit to application code
Description	The methods used to exit the BSL per MSP430 Programming Via the Bootstrap Loader (SLAU319) are invalid.
Workaround	To exit the BSL one of the following methods must be used. - A Power cycle or - Toggle the TEST pin twice when nRST is high and after 50us pull nRST low.

Note: This toggling of TEST pins is not subject to timing constraints. The appropriate level transitions on TEST pin, followed by a RST pulse after 50us, are sufficient to trigger an exit from BSL mode.
