# MSP430F5525 Device Erratasheet

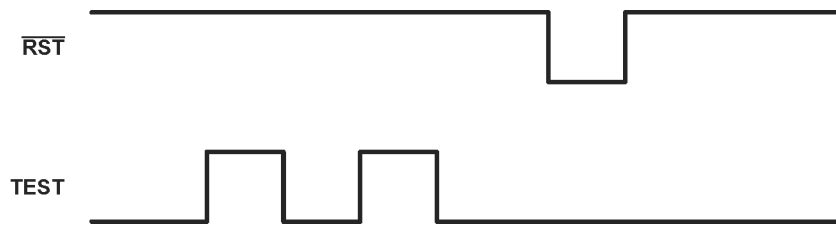
**JTAG20**
**JTAG Module**

<b>Category</b>	Software in ROM
<b>Function</b>	BSL does not exit to application code
<b>Description</b>	The methods used to exit the BSL per MSP430 Programming Via the Bootstrap Loader (SLAU319) are invalid.
<b>Workaround</b>	To exit the BSL one of the following methods must be used. - A Power cycle or - Toggle the TEST pin twice when nRST is high and after 50us pull nRST low.

Note: This toggling of TEST pins is not subject to timing constraints. The appropriate level transitions on TEST pin, followed by a RST pulse after 50us, are sufficient to trigger an exit from BSL mode.

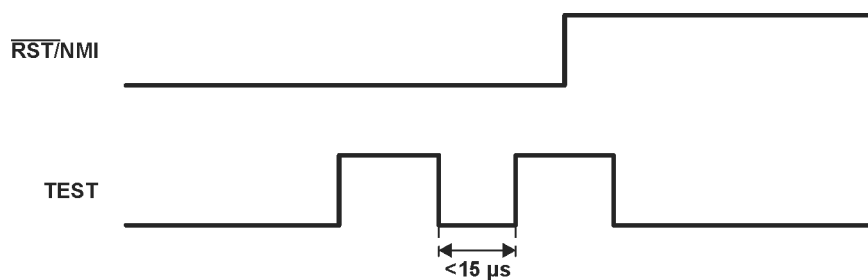
**Function** BSL entry sequence is subject to specific timing requirements

**Description** The BSL entry sequence requires that the low phase of the TEST/SBWTCK pin does not exceed 15us. This timing requirement is faster than most PC serial ports can provide, as shown in the following picture. If this requirement is not met, the entry sequence fails and the SYSBSLIND is not set.

**Workaround** An external hardware solution is recommended to provide the appropriate BSL entry sequence. See [http://processors.wiki.ti.com/index.php/BSL\\_\(MSP430\)](http://processors.wiki.ti.com/index.php/BSL_(MSP430)) for recommendations on available BSL hardware.
