Errata
MSP430G2253 Microcontroller

This document describes the known exceptions to the functional specifications (advisories).

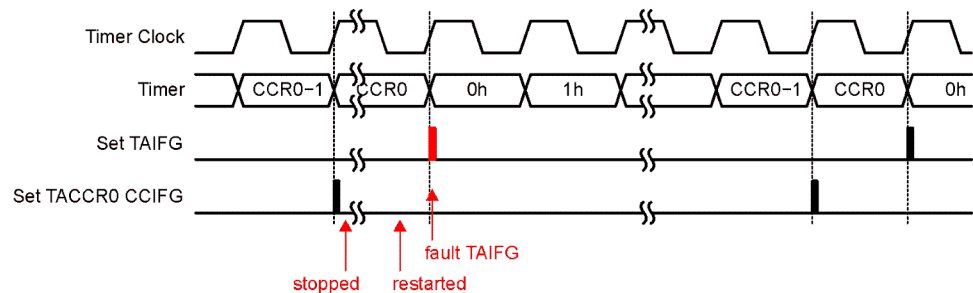
TA21 *TA Module*

Function TAIFG Flag is erroneously set after Timer A restarts in Up Mode

Description In Up Mode, the TAIFG flag should only be set when the timer counts from TACCR0 to zero. However, if the Timer A is stopped at $TAR = TACCR0$, then cleared ($TAR=0$) by setting the TACLRL bit, and finally restarted in Up Mode, the next rising edge of the TACLK will erroneously set the TAIFG flag.

Workaround None.
