Errata
MSP430G2444 Microcontroller

ABSTRACT

This document describes the known exceptions to the functional specifications (advisories).

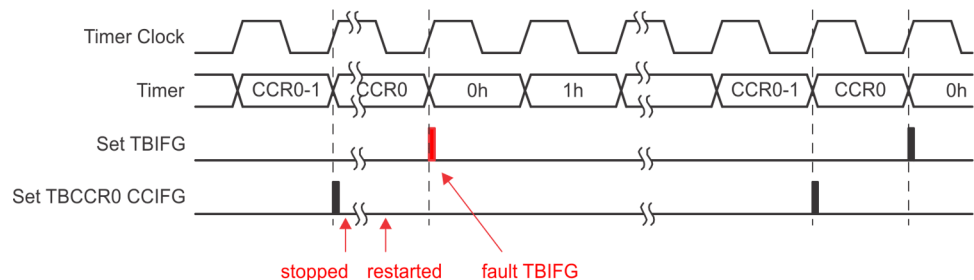
TB24 *TB Module*

Function TBIFG Flag is erroneously set after Timer B restarts in Up Mode

Description In Up Mode, the TBIFG flag should only be set when the timer resets from TBCCR0 to zero. However, if the Timer B is stopped at $TBR = TBCCR0$, then cleared ($TBR=0$) by setting the TBCLR bit, and finally restarted in Up Mode, the next rising edge of the TBCLK will erroneously set the TBIFG flag.

Workaround None.
