## **MSP432E4 SimpleLink™ Microcontrollers**

### **1 Introduction**

This document describes known exceptions to the functional specifications for the SimpleLink™ MSP432E4 microcontrollers. Note that some features are not available on all devices in the series, so not all errata may apply to your device. See your device-specific data sheet for more details.

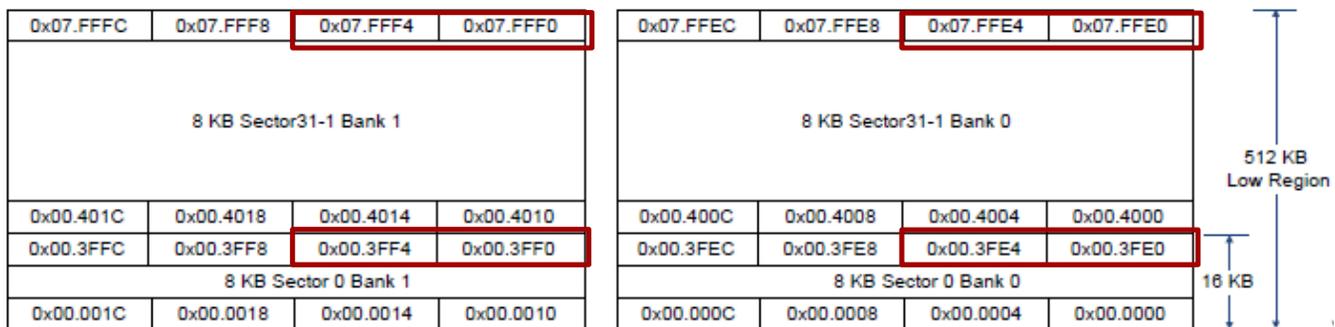
**MEM#15** *Specific flash locations in any sector do not get erased*

**Description** If only one or both of the first two words of the last line of a sector in a bank are programmed, an Erase of entire Sector, Mass Erase of device, or toggle mass erase does not erase the flash back to all 1's. The diagram below shows the affected words in Sector 0 and Sector 31 of the lower 512KB of Flash.

**Workaround** Program any other word in the Sector-Bank to allow Sector Erase to work.

**NOTE:** Toggle Mass Erase or Mass Erase will still not work.
