Errata

TMS320F2810, TMS320F2811, TMS320F2812 DSPs

This document describes the silicon updates to the functional specifications for the TMS320F2810, TMS320F2811, and TMS320F2812 digital signal processors (DSPs).

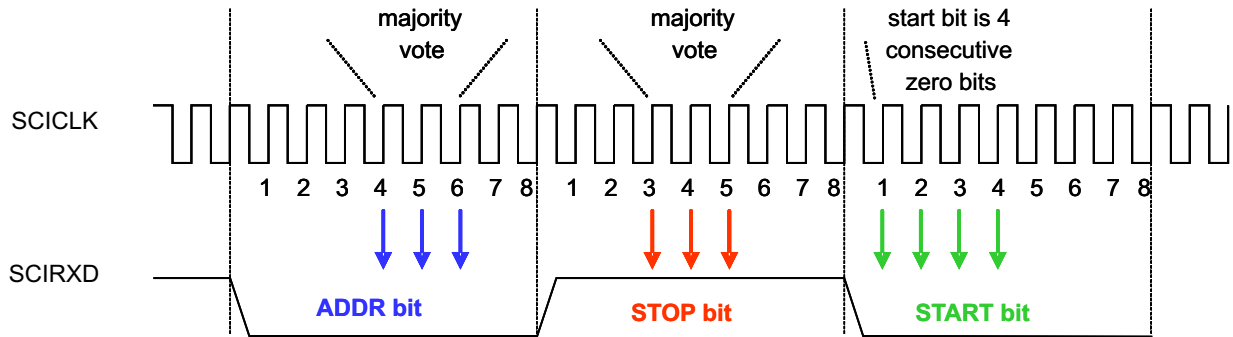
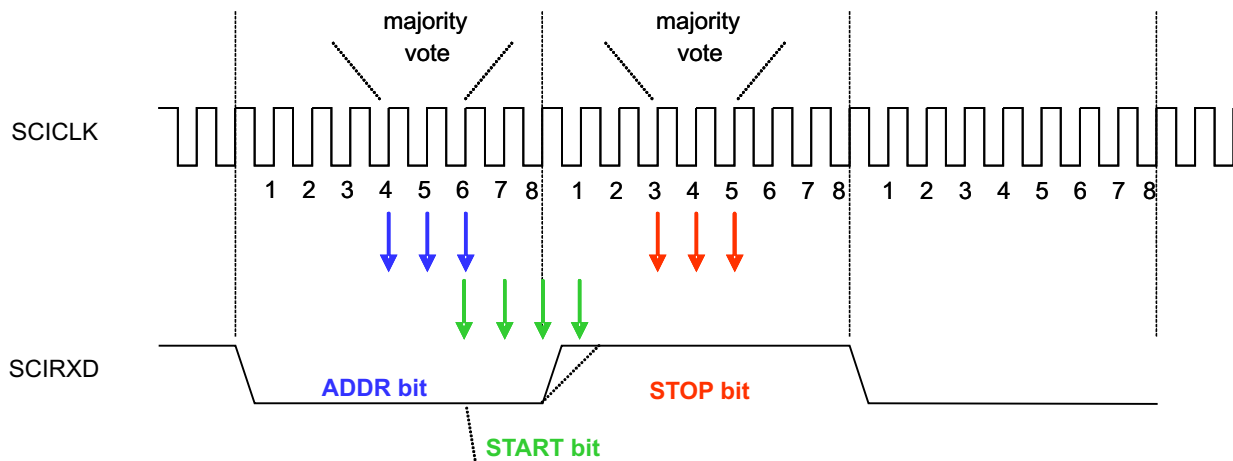
Figure 5-1. Difference Between Expected and Erroneous Operation of START Bit

Details The SCI does not look for the STOP bit after the ADDR bit. Instead, the SCI starts looking for the start bit beginning on sub-sample 6 of the ADDR bit. Slow rise time from the ADDR bit to the STOP bit can cause a false START bit to occur since the 4th sub-sample for the start bit may be sensed low.

Workaround(s) Program the baud rate of the SCI to be slightly slower than the actual. This will cause the 4th sub-sample of the false START bit to be delayed in time, and therefore occur more towards the middle of the STOP bit (away from the signal transition region). The amount of baud-slowng needed depends on the rise time of the signal in the system. Alternatively, the IDLE mode of the SCI module may be used, if applicable.
