TMS320F28044 Digital Signal Processor Silicon Revision 0

This document describes the silicon updates to the functional specifications for the TMS320F28044 digital signal processor (DSP).

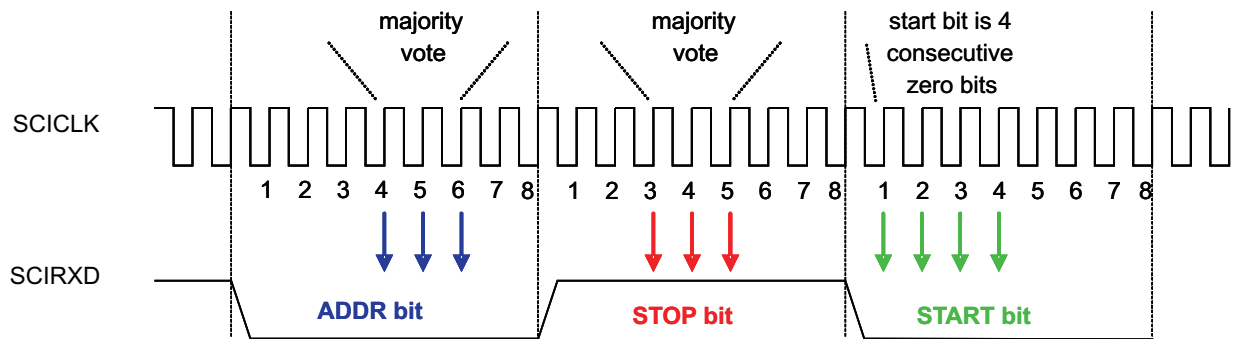
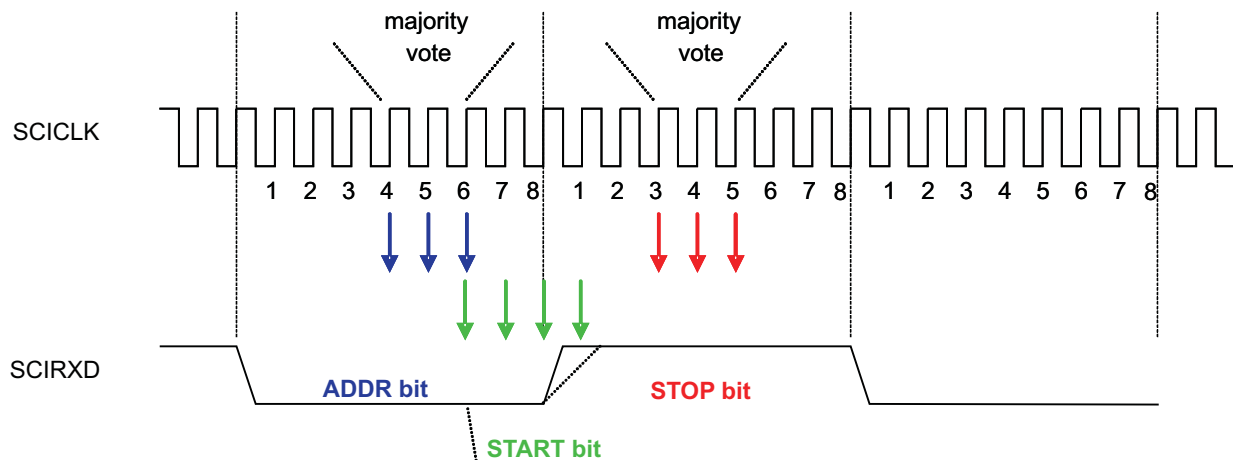
Figure 3. Difference Between Expected and Erroneous Operation of START Bit

Details SCI does not look for STOP bit after the ADDR bit. Instead, SCI starts looking for the start bit beginning on sub-sample 6 of the ADDR bit. Slow rise-time from ADDR to STOP bit can cause the false START bit to occur since the 4th sub-sample for the start bit may be sensed low.

Expected Operation:

Erroneous Operation:

Workaround(s) Program the baud rate of the SCI to be slightly slower than the actual. This will cause the 4th sub-sample of the false START bit to be delayed in time, and therefore occur more towards the middle of the STOP bit (away from the signal transition region). The amount of baud slowing needed depends on the rise-time of the signal in the system. Alternatively, IDLE mode of the SCI module may be used, if applicable.
