TMS320F2838x Real-Time MCUs Silicon Errata

Silicon Revisions A, 0

ABSTRACT

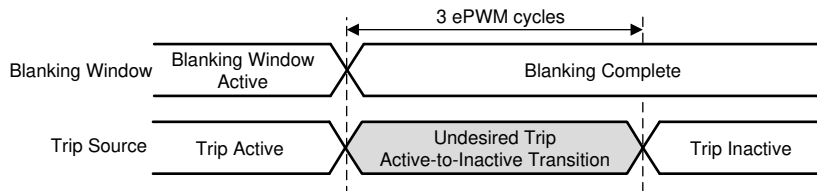
Figure 3-1. Undesired Trip Event and Blanking Window Expiration

Details The blanking window is typically used to mask any PWM trip events during transitions which would be false trips to the system. If an ePWM trip event remains active for less than three ePWM clocks after the end of the blanking window cycles, there can be an undesired glitch at the ePWM output.

Figure 3-1 illustrates the time period which could result in an undesired ePWM output.

Workaround(s) Extend or reduce the blanking window to avoid any undesired trip action.
