# DM3730, DM3725 Digital Media Processors Silicon Revisions 1.2, 1.1, 1.0

## Silicon Errata

Literature Number: SPRZ319F  
August 2010–Revised April 2014

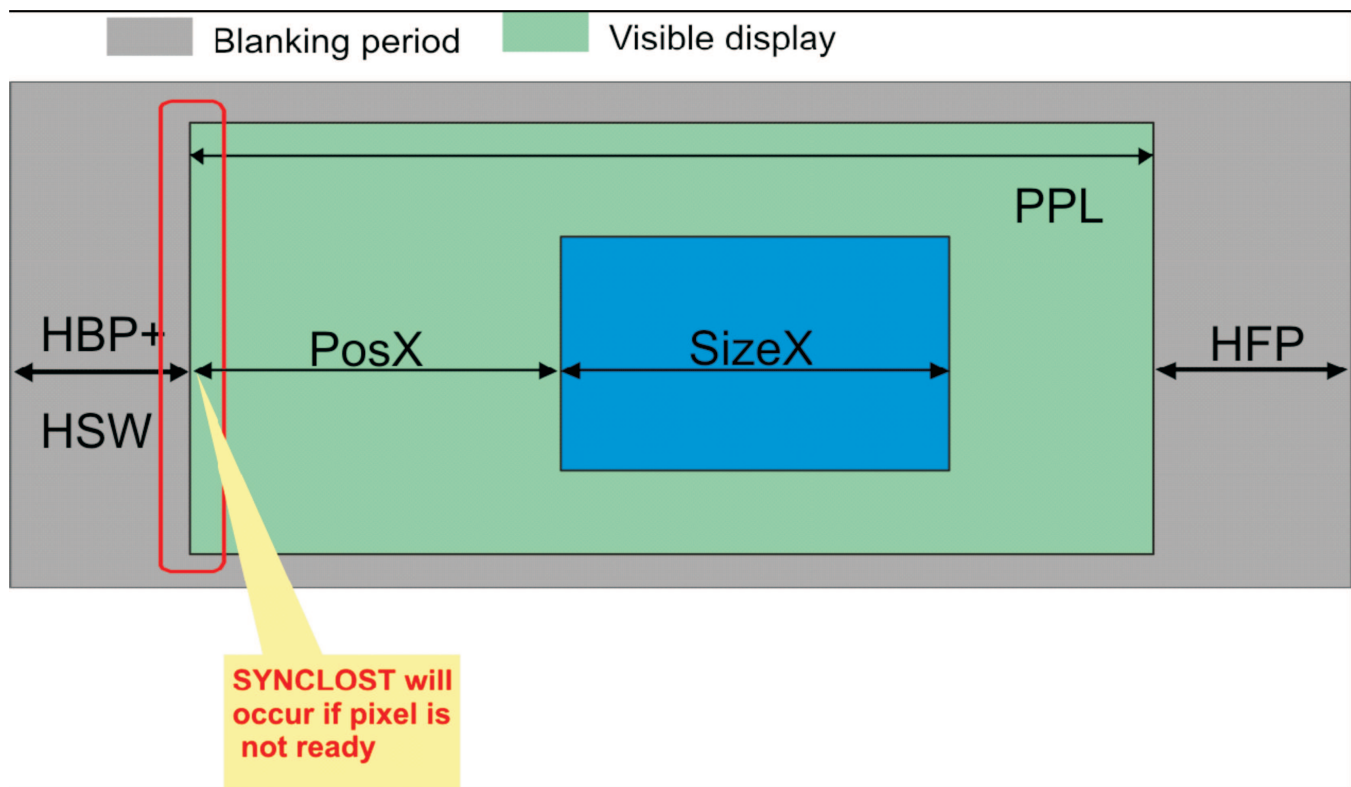
**Figure 2. Synclost Interrupt**

**Details**     Synclost interrupts are observed when performing downscaling and shifting resulting windows on the right of the LCD panel. This interrupt occurs because there is not sufficient time to load the necessary lines buffer before performing a downscaling operation. DISPC video pipeline is expected to be ready with the pixels at the end of HSW+HBP period as shown in Figure 2. This limitation is applicable on 3 and 5 taps configuration.

**Workaround(s)**     To ensure proper downscaling operation, the following conditions should be met:

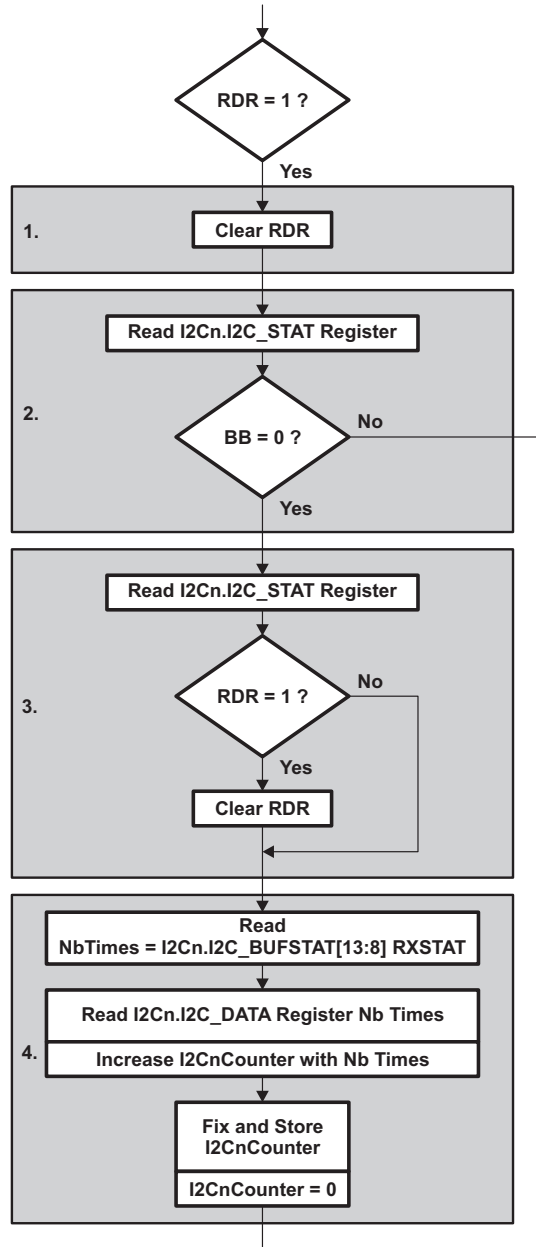
Figure 8. I2C Flowchart

**Details** Under certain rare conditions, the I2C\_STAT[13].RDR bit may be set as well as the corresponding interrupt fire, even when there is no data in the receive FIFO, or the I2C data transfer is still ongoing. These spurious RDR events must be ignored by the software.

**Workaround(s)** Software must filter out unexpected RDR pulses, using the flowchart illustrated in [Figure 8](#) when receiving an I2C RDR interrupt.

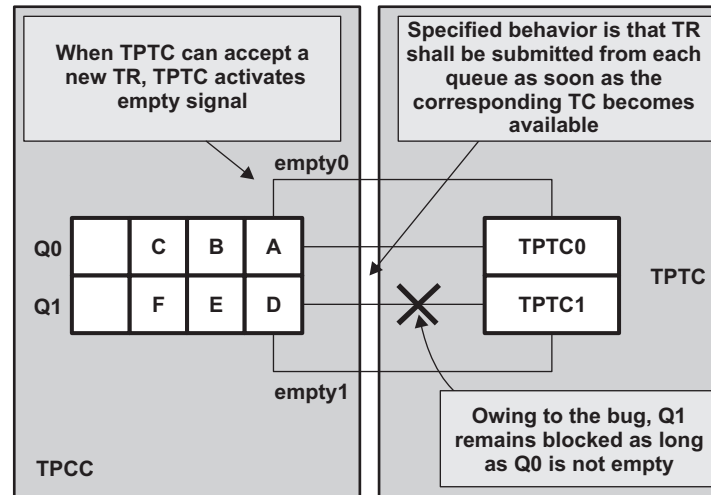
**Figure 9. TR Submission Scheme**
**Workaround(s)**

The EDMA channel controller (TPCC) has 2 event queues: Q0 and Q1. Each queue can be mapped to one of the two Transfer Controllers (TPTC): TPTC0 or TPTC1. As explained in the *AM/DM37x Multimedia Device Technical Reference Manual* (literature number [SPRUGN4](#)), the events in each event queue will be extracted as soon as the corresponding TPTC is available for a new Transfer Request (TR) to be programmed into the TPTC. However, due to an issue in the IVA2.2 subsystem, the requests queued in Q1 cannot be submitted to their TPTC as long as Q0 is not empty.

Infrequent short transfers (e.g., latency critical synchronized transfers to/from peripheral) must be placed in Q0, and longer transfers (e.g., block copy) in Q1. For example, when a latency critical transfer is placed in EDMA and a longer transfer in QDMA, the following programming model will minimize the impact of this limitation:
