# Application Note

## Lockup Avoidance for UCD3138 Devices

### ABSTRACT

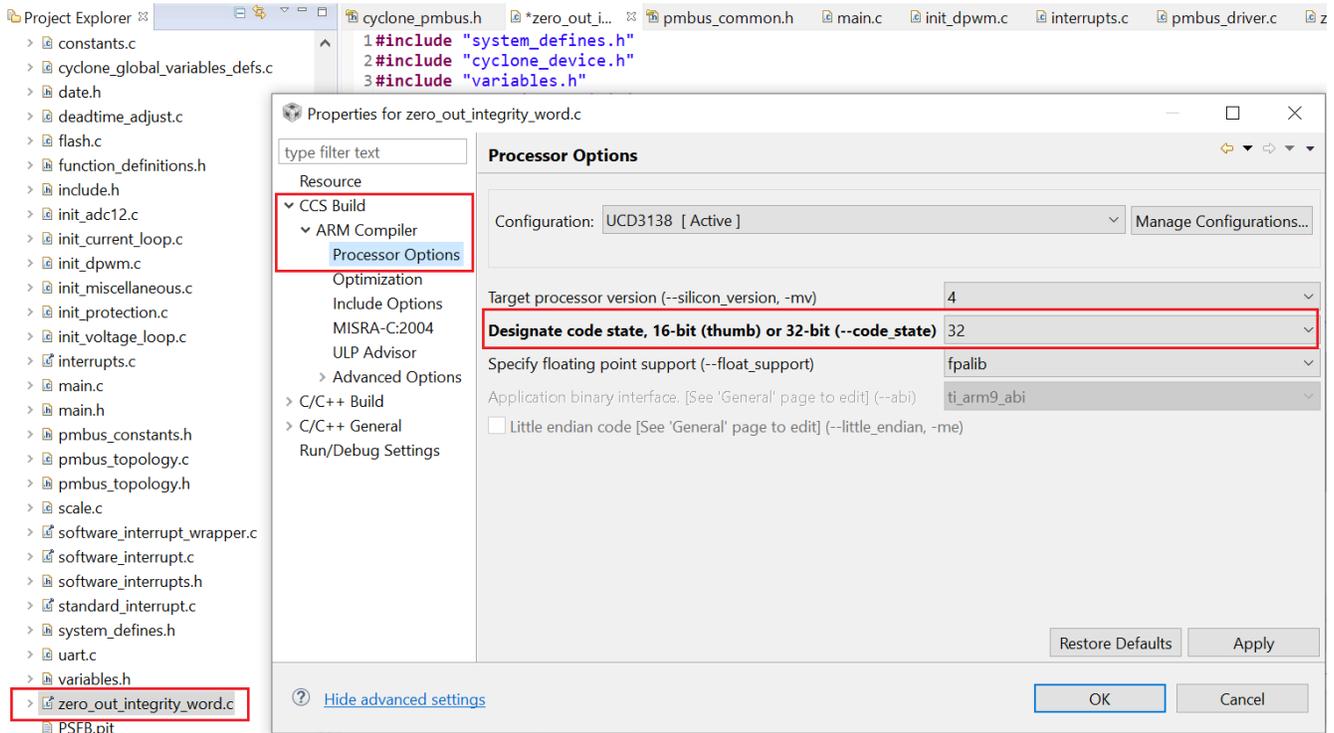
**Figure 2-2. Designating Code State**

zero\_out\_integrity\_word function is used to clear the specified location of checksum. A lockup can occur when the zero\_out\_integrity\_word function does not compile in 32-bit mode. This function is normally in an independent file named zero\_out\_integrity\_word.c. The function name or file name can be slightly different from project to project, but generally looks like the following.

Note that this option is done with the configuration in CCS, so the zero\_out\_integrity\_word function can possibly fail when the CCS version or compiler version is changed.

To check whether this function/file is compiled in 32-bit mode:

- Right click on zero\_out\_integrity\_word.c > *Properties* > *CCS Build* > *ARM Compiler* > *Processor Option* > *Designate code state*.
- If currently 16, change to 32 (as shown in [Figure 2-2](#).)
- Rebuild the project.
