# DM3730, DM3725 Digital Media Processors Silicon Revisions 1.2, 1.1, 1.0

## Silicon Errata

Literature Number: SPRZ319F  
August 2010–Revised April 2014

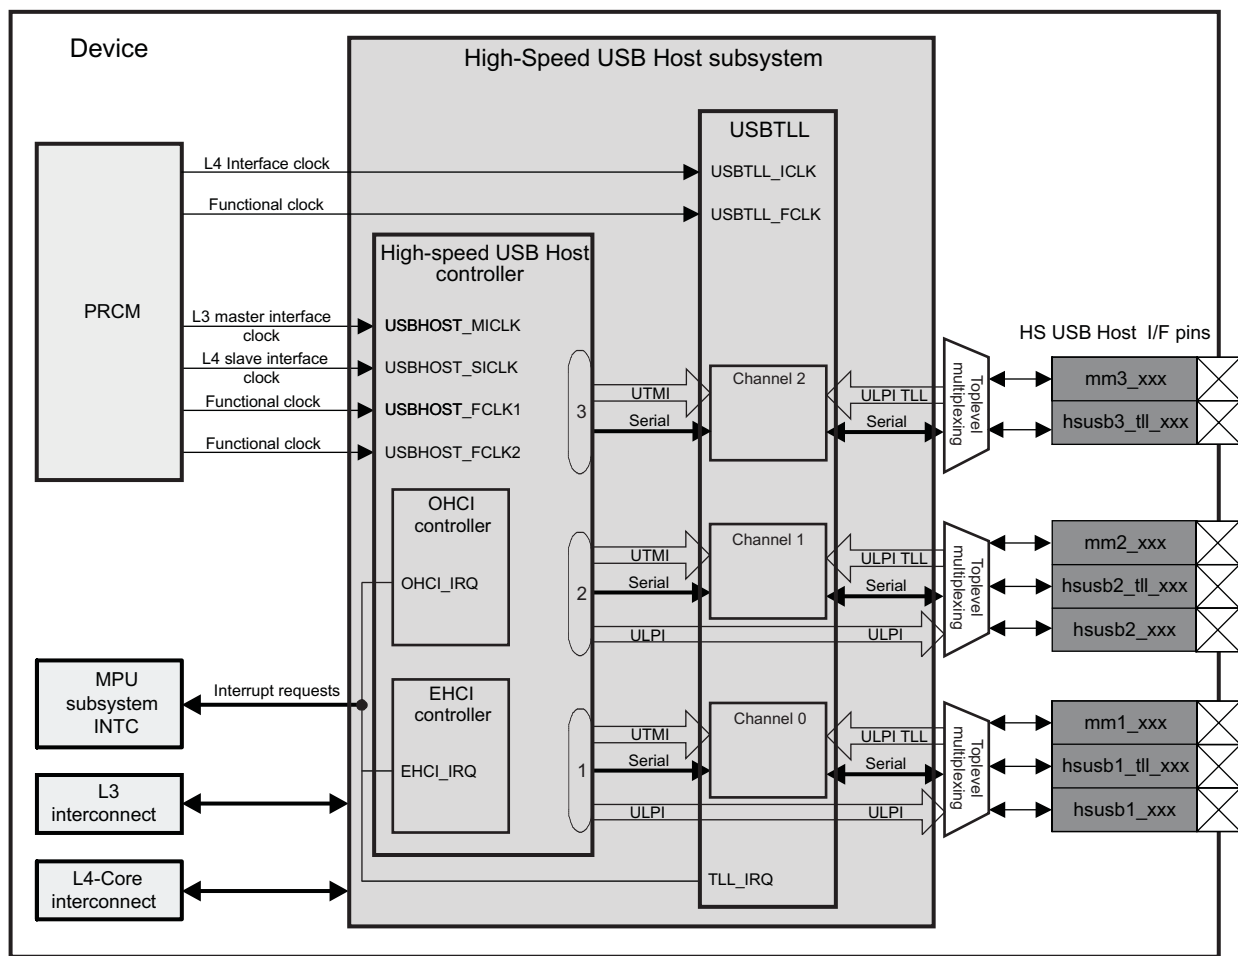
Figure 5. High-Speed USB Host Subsystem Highlight

Please note the following functional limitations when using the high-speed USB host subsystem:

- On silicon revision 1.0 only, if one port is configured in the ULPI mode, then all other ports must use the same configuration. Therefore, the ports must be configured high-speed mode or full-speed/low-speed mode. For more information, see Advisory 1.55.
- USB Port 3 cannot operate in ULPI mode; it can only operate in serial or ULPI TLL mode. Furthermore, USB Port 3 is not available in the CUS package.

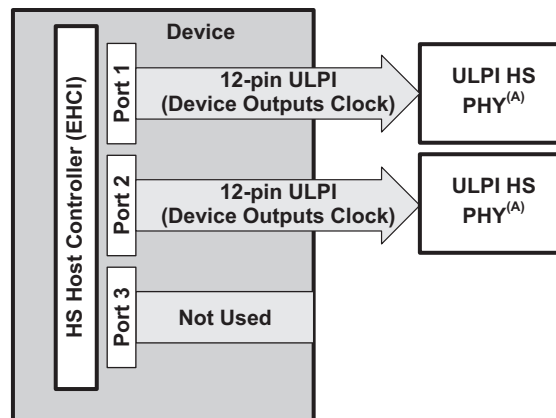
**Figure 6. Connecting to High-Speed PHYs Using USB Ports**

As shown in [Figure 6](#), USB Port 1 and Port 2 can be used to connect to external high-speed PHYs which include a ULPI port. However, in this case, the external USB PHY must be able to accept a source clock generated by the DM37x high-speed USB controller. Also, in this usage model the USB ports cannot support full-speed and low-speed operation. Therefore, using this approach, USB Port 1 and Port 2 cannot provide a fully compliant USB 2.0 Type-A receptacle; a high-speed USB hub would be required in this case; please see [Figure 7](#).

A. USB port 3 does not support ULPI mode.  
Also, USB port 3 not available on CUS package.

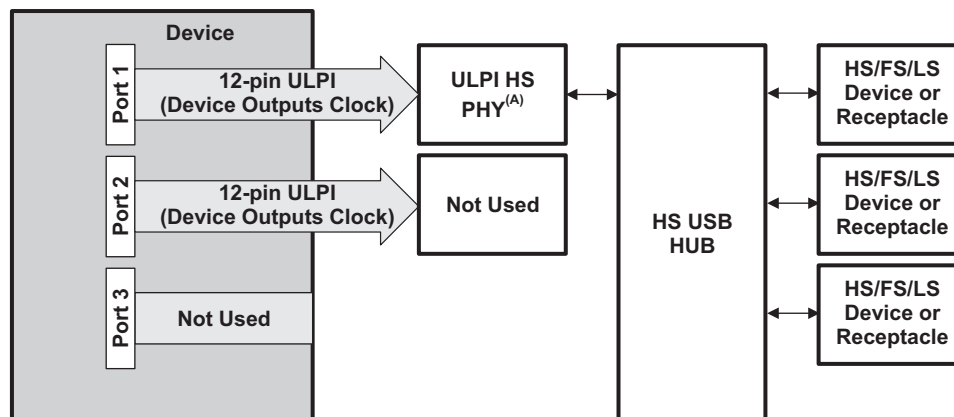
**Figure 7. Connecting to a High-Speed USB Hub**

A. USB port 3 does not support ULPI mode. Also, USB port 3 not available on CUS package.

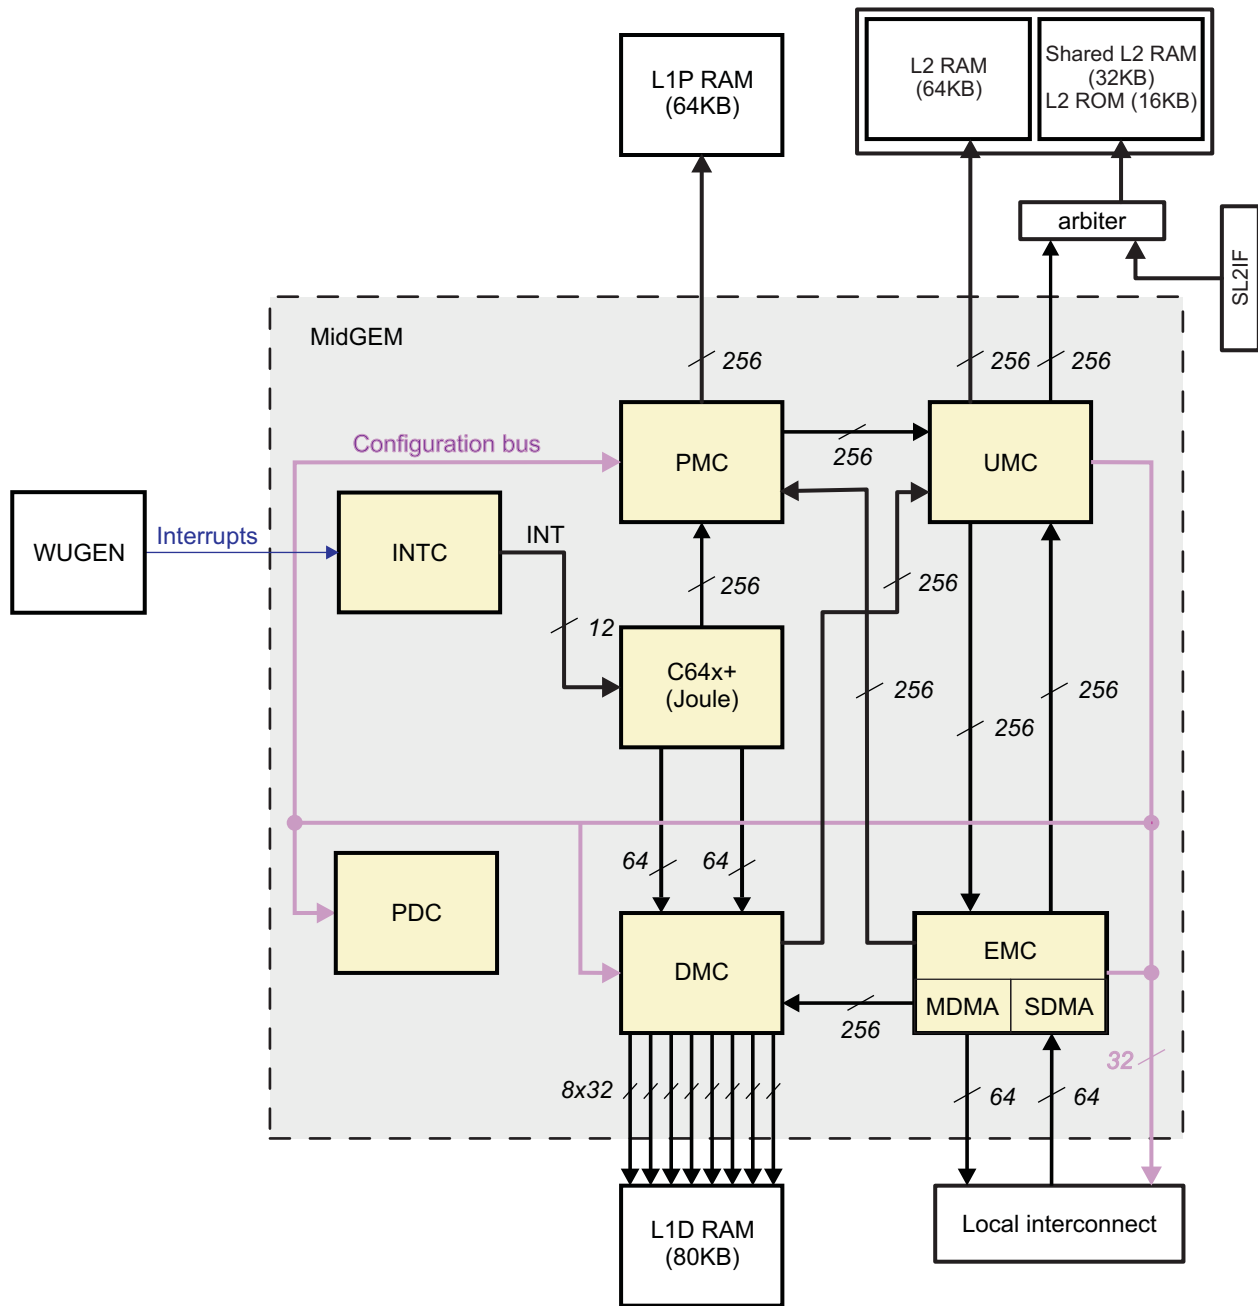
Figure 13. C64x+ Megamodule Block Diagram

Ideally the MDMA and SDMA/IDMA paths operate independently with minimal interference. Normally MDMA accesses may stall for extended periods of time (clock cycles) due to expected system level delays (e.g. due to bandwidth limitations and/or DDR memory refreshes). However, due to the exception, there are cases where SDMA and/or IDMA accesses to L2/L1 experience an additional/unexpected stall during the normal stalls seen by the MDMA interface. For latency sensitive traffic, the SDMA stall can result in missing real time deadlines.

**Note:** SDMA/IDMA accesses to L1P/D will not see any unexpected stall if there are no SDMA/IDMA accesses to L2 (both cache/SRAM and shared SRAM). This is because unexpected SDMA/IDMA stalls to L1 happen only when they are pipelined behind L2 accesses which experience stalls due to the exception.
